NTSB/HAR-02/03
PB2002-916203

Highway Accident Report

Collision Between Truck-Tractor Semitrailer and School Bus Near Mountainburg, Arkansas on May 31, 2001

National Transportation Safety Board
Washington, D.C.

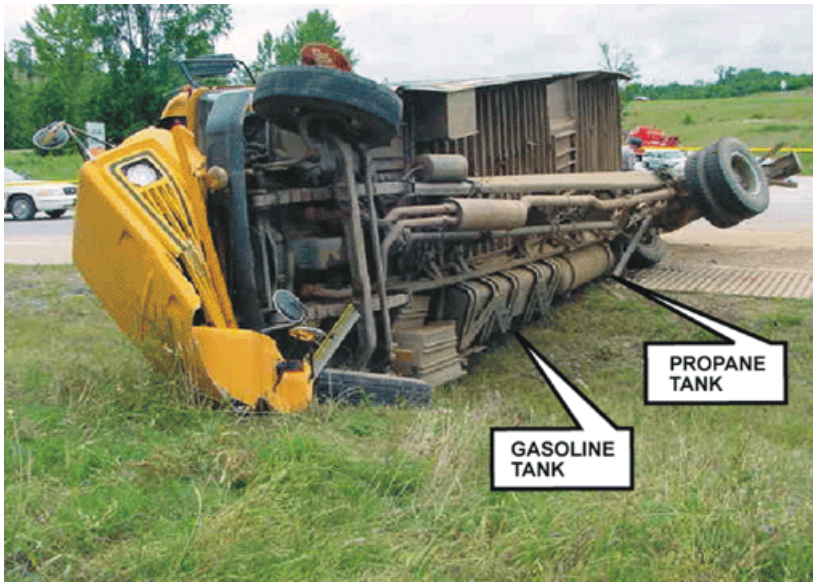
Figure 8. School bus propane tank.

The *National School Transportation Specifications and Procedures*[19] recommends that all propane tanks, including those installed on vehicles, comply with NFPA standard 58,[20] which specifies requirements for the propane tanks themselves and for their placement and installation. The NFPA requires that propane tanks be located where the possibility of damage is minimized. It states that containers in the rear of vehicles should be protected by substantial bumpers; those near the engine or exhaust system should be shielded from direct heating. Containers should not be mounted on the roof, ahead of the

front axle, or behind the rear axle and should not protrude beyond the vehicle's sides or top. Containers mounted between the axles should have ample road clearance and should not be lower than the lowest point of the body, frame, engine, or transmission. The NFPA further requires that the container be securely mounted to prevent jarring loose, slipping, or rotating.
